# Oregon State Capitol Master Plan

June 2009

SRG PARTNERSHIP INC  
ARCHITECTURE PLANNING INTERIORS

The purpose of the Existing Building Assessment is to evaluate the condition of the building and its systems as a baseline for formulating strategies for its preservation and future evolution. The building has been well maintained and incrementally updated over its 70-year life, but not all advancements in codes, safety systems and technology have been integrated into the building infrastructure.

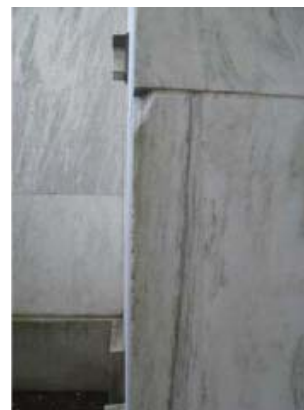
EXAMPLE OF SPALLING AT THE CORNER OF A MARBLE PANEL

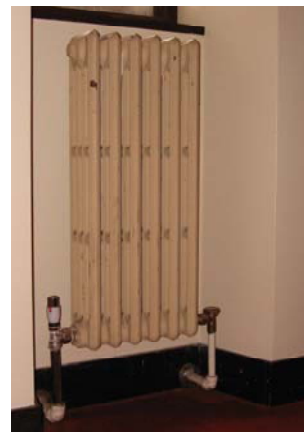
STEAM CONVECTORS

- » Steam Convectors: Installed in 1938 and have exceeded their expected useful life.
- » Fan Coil Units: Installed in 1968 and have exceeded their expected useful life, other than those in specific areas that have been replaced, principally the areas affected by the 2008 fire.
