# Oregon State Capitol Master Plan

June 2009

SRG PARTNERSHIP INC  
ARCHITECTURE PLANNING INTERIORS

The purpose of the Existing Building Assessment is to evaluate the condition of the building and its systems as a baseline for formulating strategies for its preservation and future evolution. The building has been well maintained and incrementally updated over its 70-year life, but not all advancements in codes, safety systems and technology have been integrated into the building infrastructure.

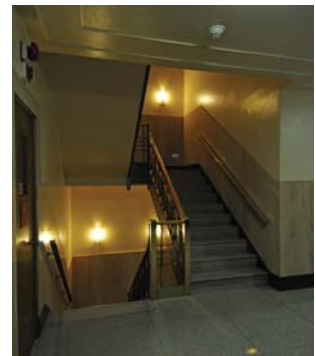
- » The corridors outside the two chambers leading to the north are technically 110' dead ends (without exits), far in excess of the allowed 20 feet.
- » The two north Hearing Rooms only have one means of egress from each; two are required by code.

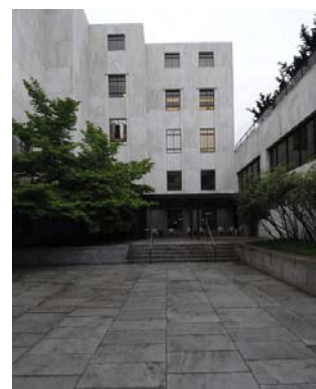
- » There are no handrails on: 1) exterior stairs, except at the south; 2) on monumental stairs off of the Rotunda; 3) on stairs from ground floor to the courtyards (note: handrails are also required for egress reasons).

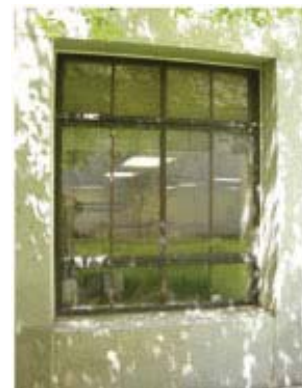
From the ground visual inspection showed that the bronze windows at the 1938 Capitol are in good condition. There were no instances of cracked glazing, metal corrosion or damaged window sections noted. This study recommends conducting both a detailed window survey and additional field testing. Specifically, the survey should include the presence and degree of any corrosion of the bronze; condition of patina; deterioration of the metal sections, including bowing, misalignment of the sash, or bent sections; condition of the glass and glazing compound; presence and condition of all hardware, screws, bolts, and hinges; and condition of the granite or marble surrounds, including need for caulking or resetting of improperly sloped sills.

If any of windows are found to be damaged in any of the aforementioned ways, depending on their condition they can either be repaired in place or removed and repaired in an off-site facility. The original bronze windows are non-laquered, and it is recommended that all remain with their natural patina, which was the original design intent. Bronze windows are generally not energy efficient, and this has often led to their wholesale replacement. They can, however, be made more energy efficient in several ways, varying in complexity and cost. Caulking around the stone openings and adding weather-stripping are important first steps in reducing air infiltration around the windows. Other treatments include applying fixed layers of glazing over the historic windows, adding operable storm windows, or installing thermal glass in place of the existing glass. In combination with caulking and weather-stripping, these treatments can greatly enhance energy ratings.

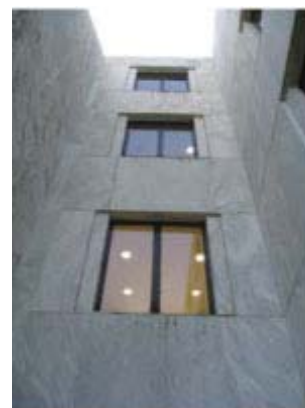
From the ground visual inspection showed that the bronze anodized aluminum windows at the 1977 addition are in good condition. As with the bronze windows at the 1938 Capitol, it is recommended that a detailed window survey be conducted.

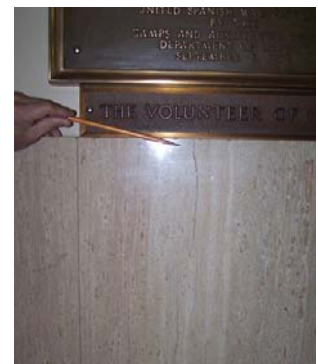
In general, the Rotunda interior historic materials are in good overall condition. Some areas appear to have been repaired in the past. These repairs are of high quality and in sound condition. In sporadic areas the stone joints of the wainscot panels are missing mortar. A marble trim detail along the edge of the balcony across from the second level Governor’s Suite has spalled and symmetrical cracks thru the marble base occur on either side of the south portal. The current study did not include intensive research in order to determine if the current cracking and other deficiencies within the Rotunda are a result of existing stone panel movement or a result of past movement from seismic activity. The marble floor has one crack on axis with the entry doors running north south along the north edge. Within the Rotunda, the only surfaces with ongoing pattern deficiencies are the outside ends of the stair nosing. Evidence of past repairs at the nosing indicates spalling occurs at the nosing ends adjacent to the walls. One failure of an existing nosing repair and one new nosing failure was noted.

On the northern edge of the Rotunda stairs, the cracked portion of the failed nosing should have a Dutchman repair. In the basement, a few of the previously repaired marble door surrounds have re-cracked and should be either repaired or replaced. The process of repairing any door surrounds that have cracked all the way through requires the removal and “gluing” back together of the two pieces, and then the reinstallation of the fixed piece. Epoxy injection into cracks is a common repair method. Such methods require the crack to be prepared by cleaning the crack with high pressure air and pre-drilling holes, or ports, for the entry and exit locations of the epoxy material. It is suggested that repair of interior marble panels with epoxy occur on the back side. Once the crack is prepared, products selected for their viscosity and compatibility with the marble are selected and installed along the crack. Pre-testing the procedure on flat panels off-site is highly recommended in order to evaluate aesthetic impact to the marble panel system.

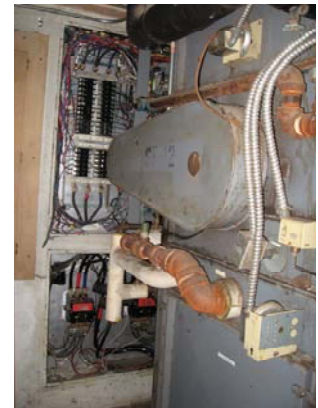
POOR PANEL ACCESS

- » There are abandoned cables throughout the facility. The current National Electrical Code requires that all abandoned cables be removed.
- » Panel directories and other types of circuit identification are not up to date.
